Raw water system overhaul

Stu Davies shows how he serviced and improved the raw water system on *Sacha*, his Bénéteau 381

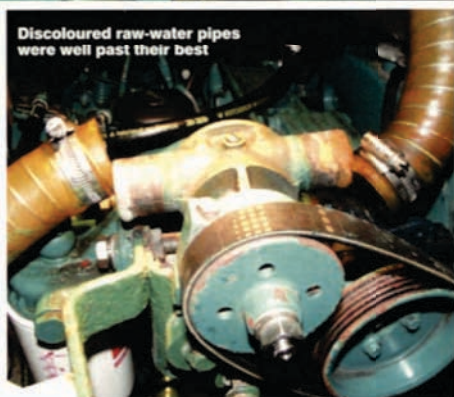
Discoloured raw-water pipes were well past their best

My boat is fitted with a 12-year-old Volvo Penta MD22 engine and the cooling system was starting to look its age, with discoloured, distorted and stiff

hoses to and from the inlet and raw water pump. It was time for an overhaul.

I decided to address all these problems at once by renewing the wire-reinforced hose, fitting a Speedseal to the water pump and a new seal to the water strainer, stripping and cleaning the anti-siphon valve and cleaning away the rust on the engine block.

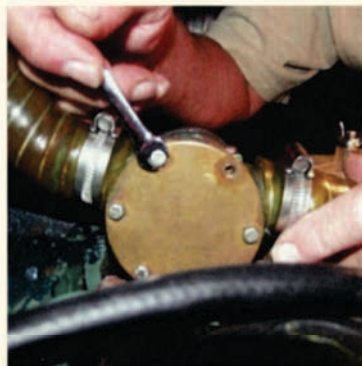
1 The original water pump cover is held in place with six set screws

Time to fit the Speedseal. The original Volvo cover plate is secured by six set screws. The Speedseal replaces these with four large knurled thumbscrews, two of which are left in place when the cover is removed. The new cover plate sits on top of a PTFE washer, which means the pump can be run dry for a short while without doing too much damage. The original cover plate gasket is replaced by an O-ring, located in a groove in the cover plate, so no more worrying about damaging the gasket when changing the impeller.

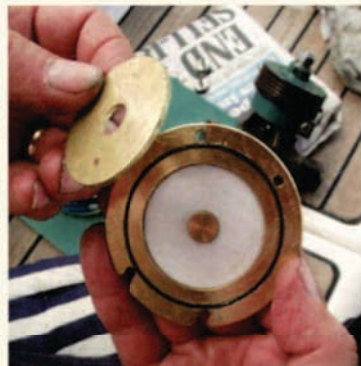
2 The replacement Speedseal cover features a PTFE washer and rubber O-ring seal

All I have to do now to change the impeller is to remove the two top knurled screws, slacken the two bottom ones and slip the cover off.

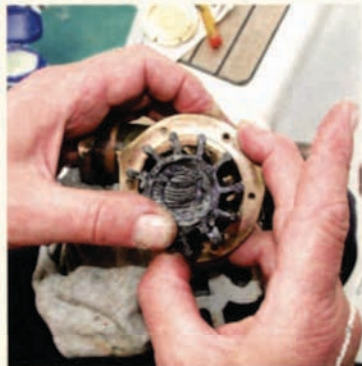
3 Impeller vanes must face the right direction when pushed inside the water pump body
