Raw water system overhaul

Stu Davies shows how he serviced and improved the raw water system on *Sacha*, his Bénéteau 381

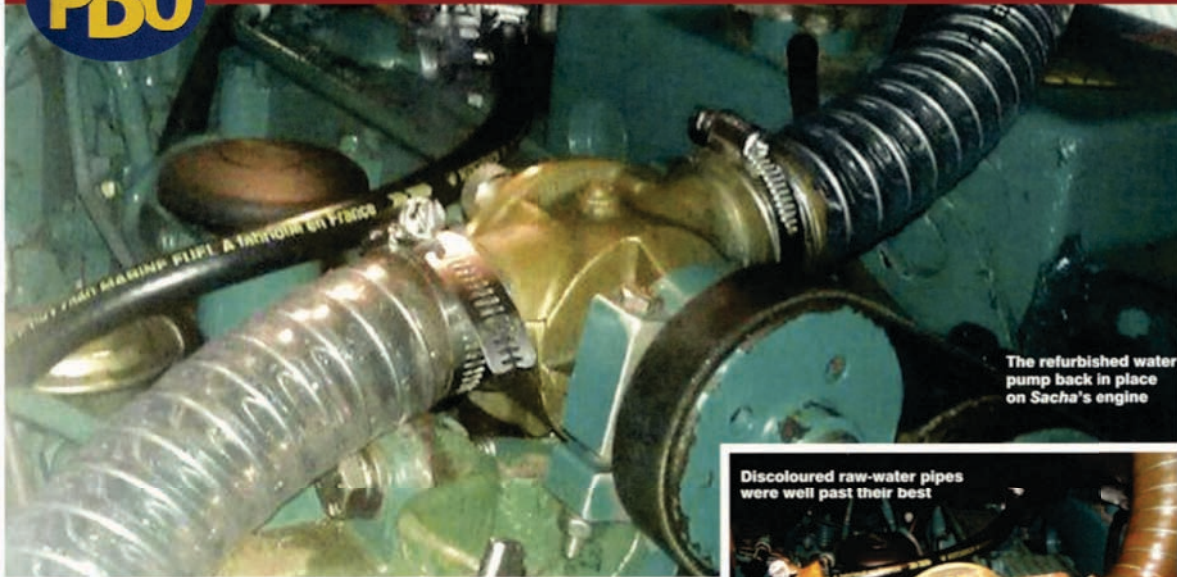
The refurbished water pump back in place on Sacha's engine

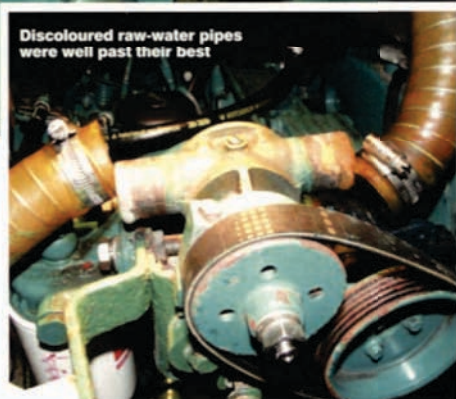
Discoloured raw-water pipes were well past their best

My boat is fitted with a 12-year-old Volvo Penta MD22 engine and the cooling system was starting to look its age, with discoloured, distorted and stiff

hoses to and from the inlet and raw water pump. It was time for an overhaul.

Hose replacement was easy – just a case of removing the hose clips, removing the old hose and using it

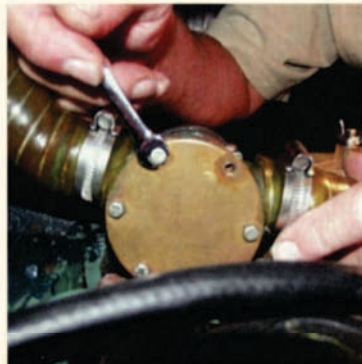
1 The original water pump cover is held in place with six set screws

Time to fit the Speedseal. The original Volvo cover plate is secured by six set screws. The Speedseal replaces these with four large knurled thumbscrews, two of which are left in place when the cover is removed. The new cover plate sits on top of a PTFE washer, which means the pump can be run dry for a short while without doing too much damage. The original cover plate gasket is replaced by an O-ring, located in a groove in the cover plate, so no more worrying about damaging the gasket when changing the impeller.

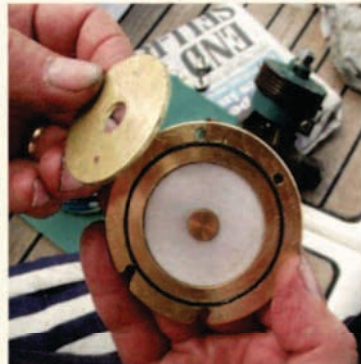
2 The replacement Speedseal cover features a PTFE washer and rubber O-ring seal

All I have to do now to change the impeller is to remove the two top knurled screws, slacken the two bottom ones and slip the cover off.

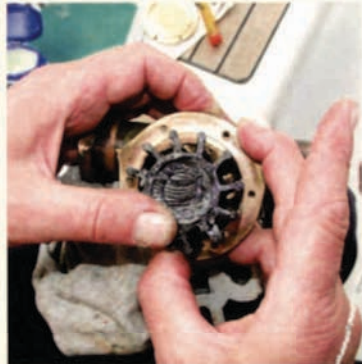
3 Impeller vanes must face the right direction when pushed inside the water pump body
